**BPG Inspection, LLC**

Inspection Date: 4/17/2026

Inspector: Romeo Montalvo , TREC # 25424-PI (TX)

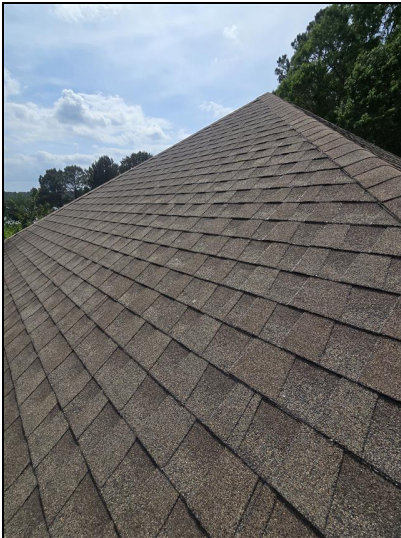
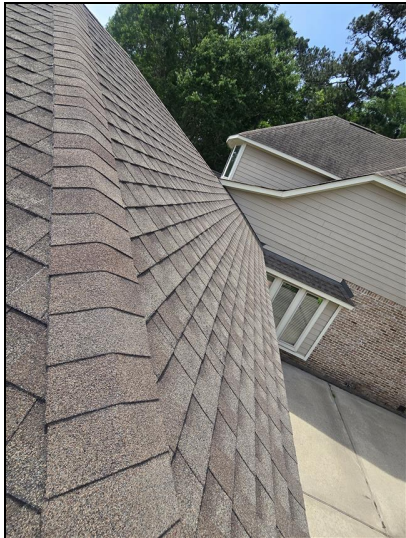
☒ Remove all debris from roof slopes and valleys. Leaf debris may hide possible defects and damage to roofing materials. Debris may also cause water to dam up under shingle tabs.

Newer, cleaner shingles in this area communicates their were previous repairs and or updates done to roof. Although no issues in attic or under deck you may want to inquire of the intent of the repair.

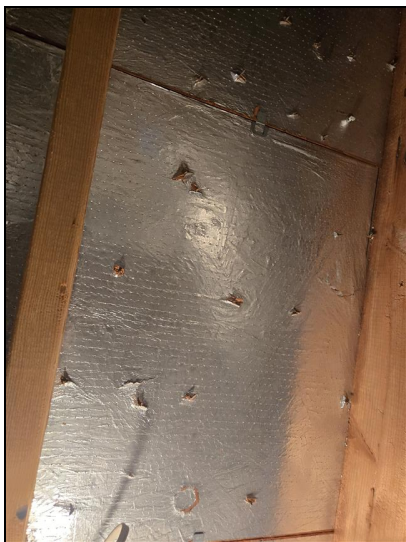
Noted attic of home with radiant barrier installed, noted no concerns with installation. Radiant barrier sheathing with its thin laminated aluminum layer, prevents up to 97% of the radiant heat in the panel from radiating into the attic. Attic temperatures can be reduced by as much as 30°F.

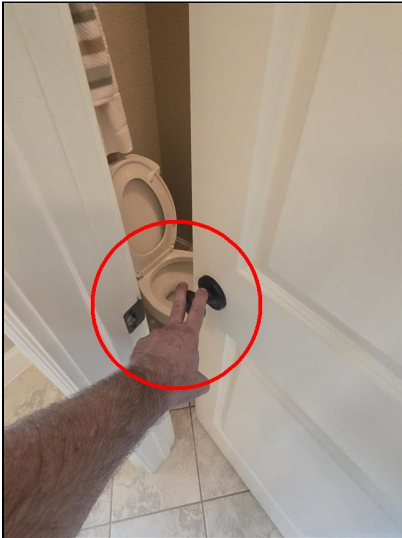
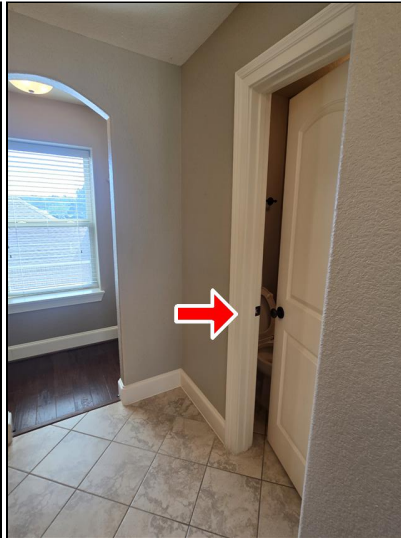
☒ One door upstairs leading to bathroom that when closed does not secure fully and completely. Recommend having doors or hardware on doors adjusted to have doors operate as designed.

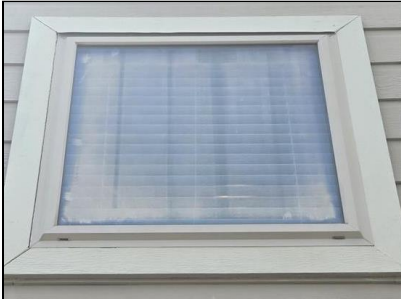
Although double-paned windows appear to be stable, they actually experience a daily cycle of expansion and contraction caused by thermal pumping. This process occurs when sunlight heats the air space between the panes and causes the gas there to heat up and pressurize. Expanding gas cannot leave the chamber between the panes, and causes the glass to bulge outward during the day and contract at night to accommodate the changing pressures. This motion acts like the bellows of a forge, pumping minute amounts of air in and out of the air space between the panes. Over time, the constant pressure fluctuations caused by thermal pumping will stress the seal and challenge its ability to prevent the flow of gas in and out of the window chamber. If it is cold enough, incoming humid air has the potential to condense on the window's surface.

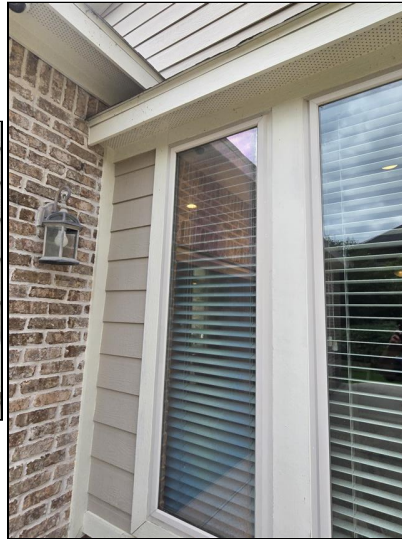
☒ The glazing between glass panes are failing at some windows (condensation/fogging between panes). Double-pane windows have a layer of gas -- usually, argon or air -- trapped between the two panes of glass and should be insulated enough to prevent the accumulation of condensation. If this type of window appears misty or foggy, it means that its seal has failed and the window needs to be replaced.

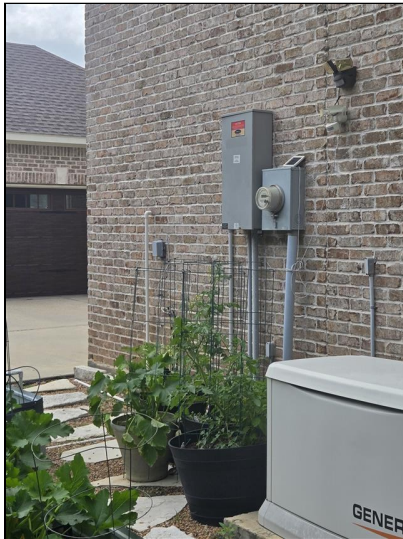
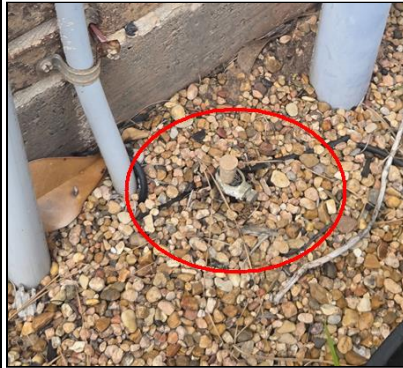
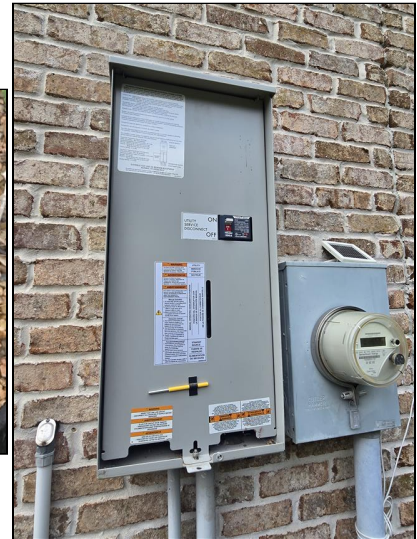
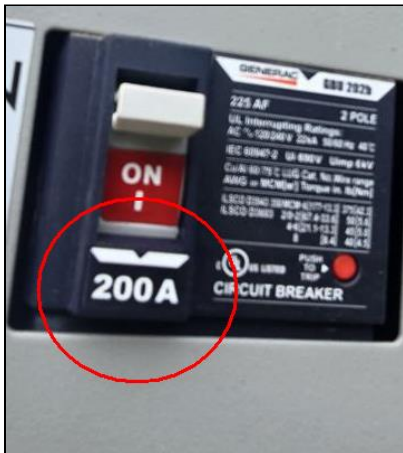
200 A

System panels installed correctly, grounded and bonded.

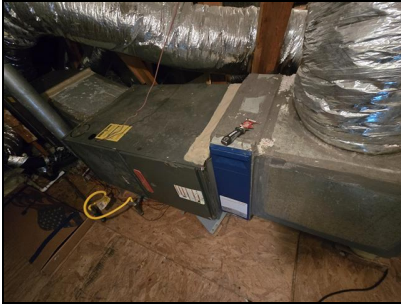
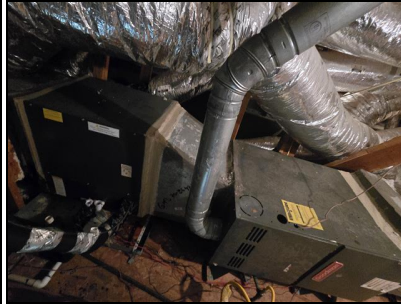
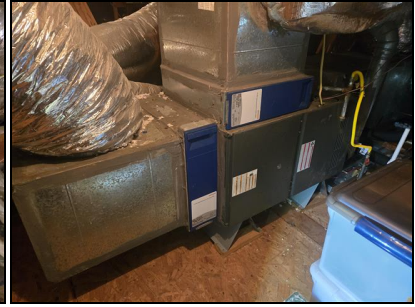
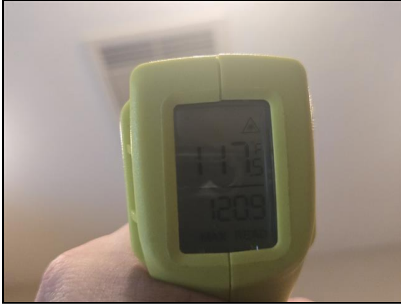
117 First Floor

The unit functioned at the time of inspection. Proper heating operation is determined by a minimum of 100 degrees being supplied from all home supply grills.

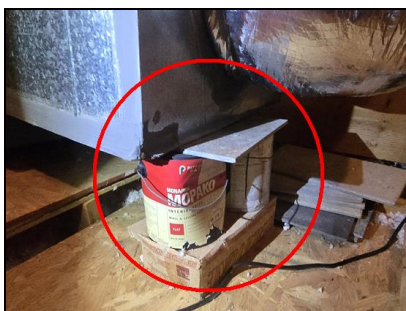
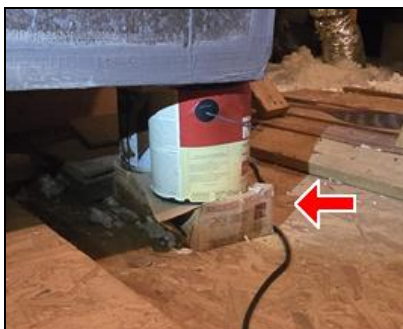
☒ Right side furnace does not have proper support, to prevent possible future damage have professional place intended manufacturers supporting.

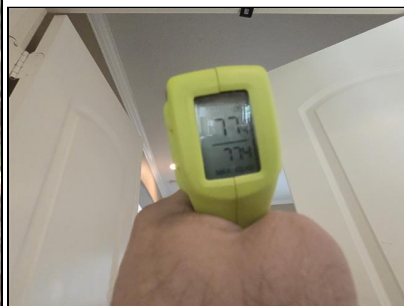
At Return, First Floor

The downstairs and upstairs unit functioned at time of inspection. Target temperature drops between 15-22 degrees were obtained.

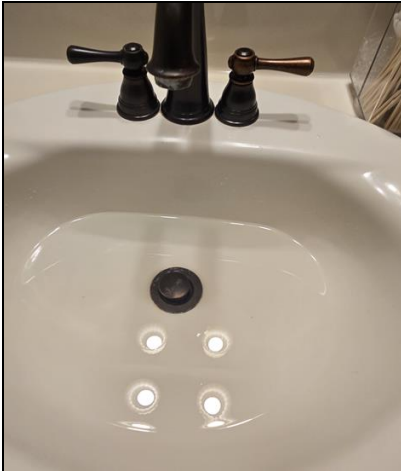
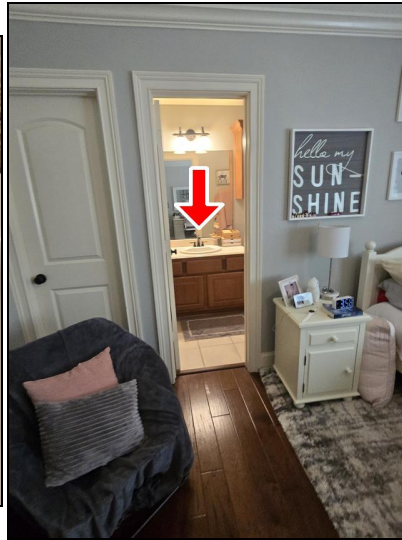
Drain stops were missing in the hall bath sink.

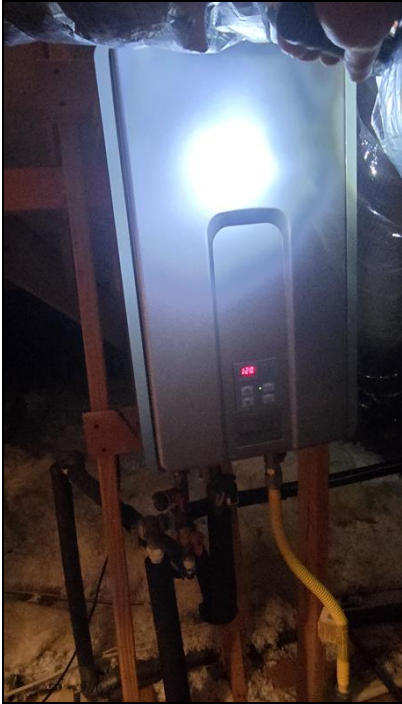
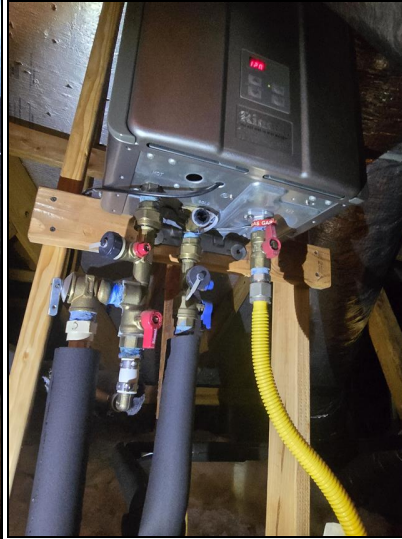
- ✖ 10. The water heater did not produce enough hot water at time of inspection. Temperature readings at sinks were less than 100 degrees. Recommend having a licensed plumber further evaluate and make the necessary repairs/replacements before your closing date.

76 Degrees after 10 min being on

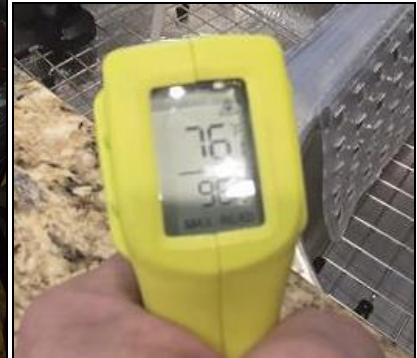
☒ The water heater did not produce enough hot water at time of inspection. Temperature readings at sinks were less than 100 degrees. Recommend having a licensed plumber further evaluate and make the necessary repairs/replacements before your closing date.

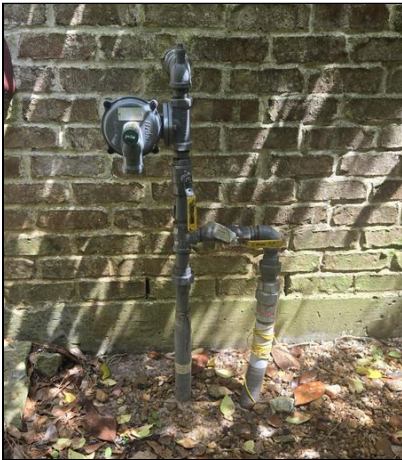
☒ ☐ ☐ ☐ E. Gas Distribution Systems and Gas Appliances  
Comments:  
No leaks were present at time of inspection.

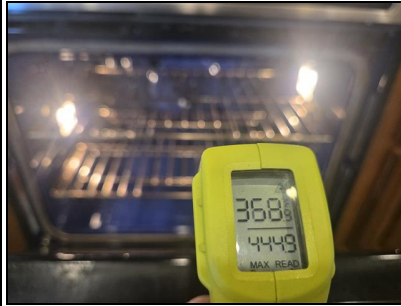
Set at 350

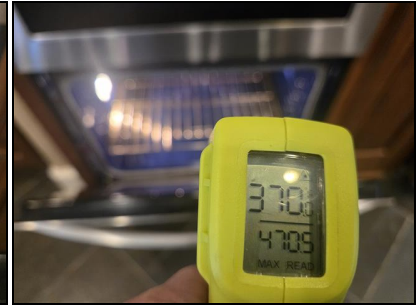
Set at 350

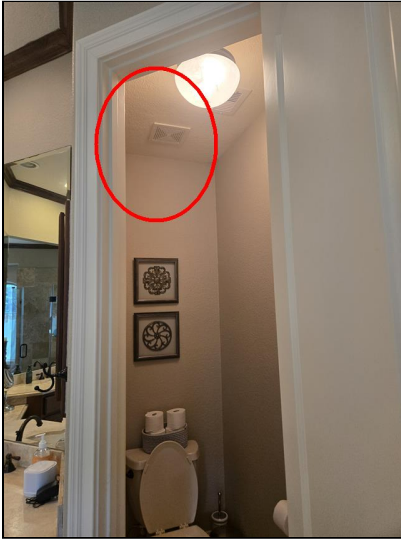
Master Bath

☒ Master bath restroom exhaust fan makes vibration noise. Recommend having exhaust fan tightened or replaced.

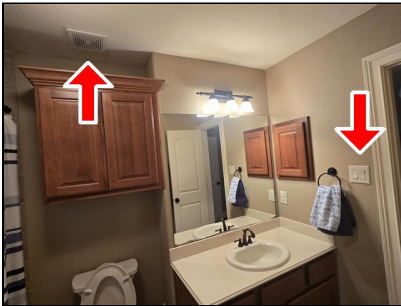
Upstairs Bathroom

Upstairs bathroom exhaust fan was not operational at time of inspection, have replaced.

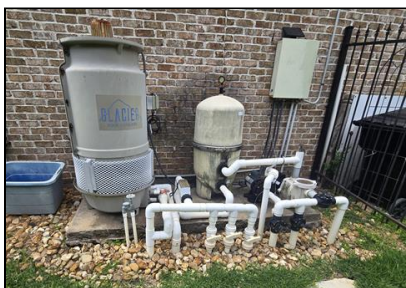
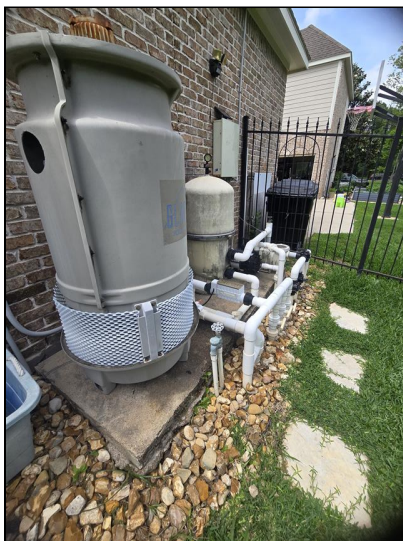
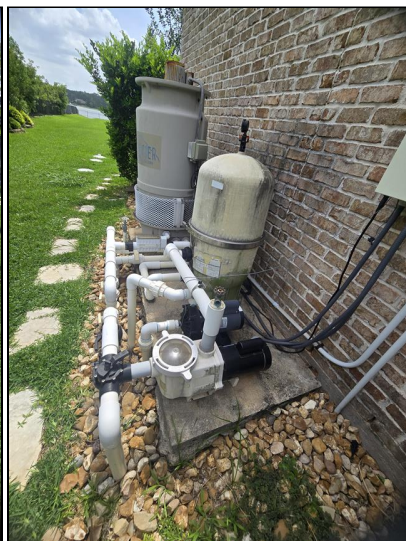
The pool equipment was functional at the time of inspection.

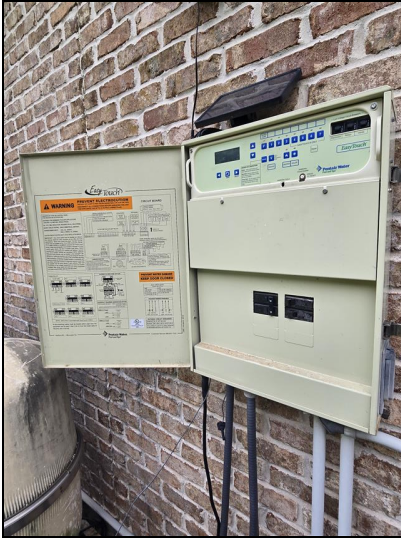
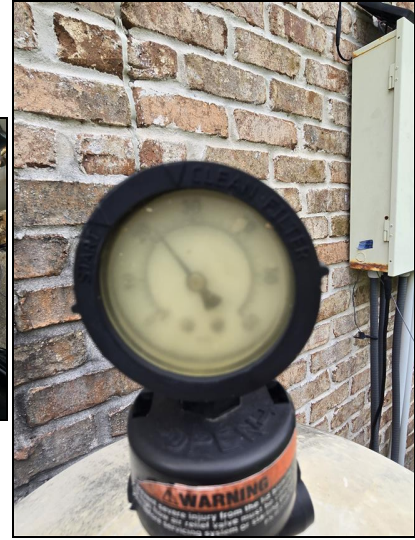
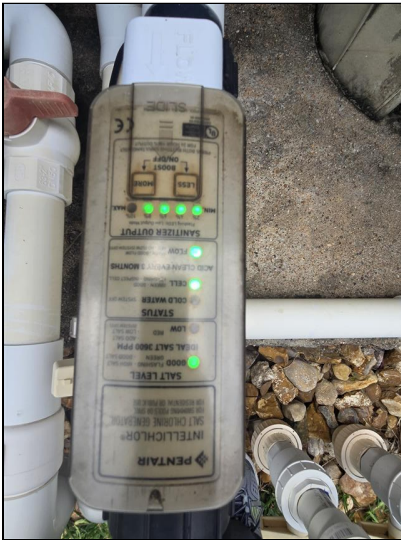
☒ Rear door and windows that face the pool area do not have an audible alarm system installed as called for by today's child safety standards.

☒ The rear fence gate(s) is not self closing and latching as called for by today's child safety standards.

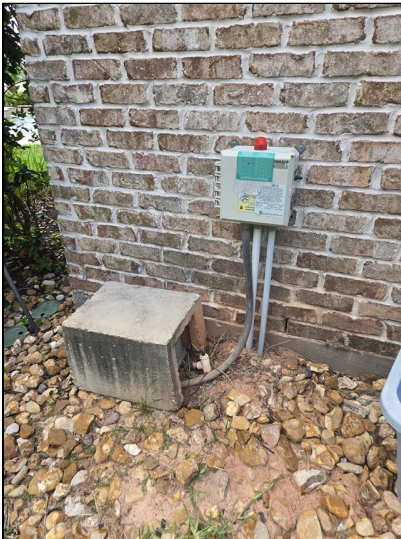
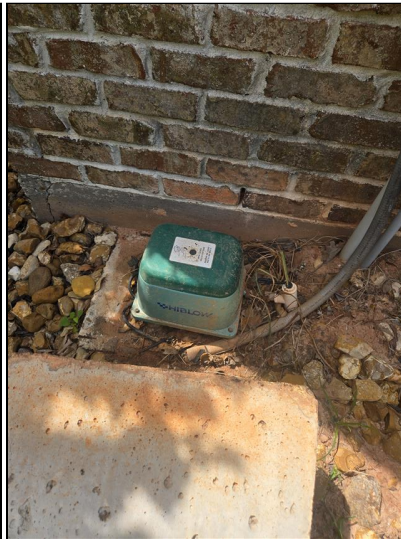
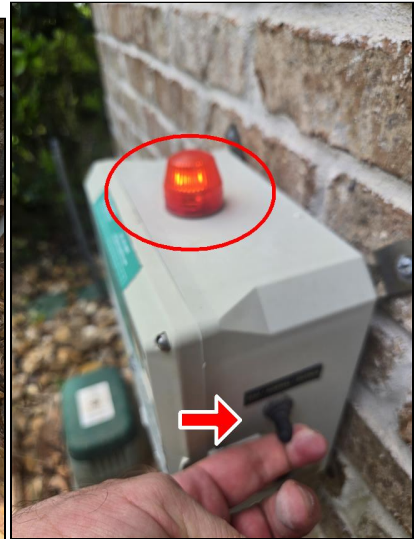
I inspected the property in the location of the drain field area of septic. There were no signs of failure or blockage and the grounds appear normal. I visually located the septic ports and removed them to view interior of tanks. The visible tanks were in good condition. The floats properly operated the pump and alarm devices when tested. The aerator was functioning normally at inspection.

Changes in water volume use can sometimes have an impact on septic tanks that before were working properly. Most septic contractors recommend that if the septic tank hasn't been pumped and inspected in the

last 4-5 years, you should have it pumped and inspected visually during the inspection process to determine its true condition.

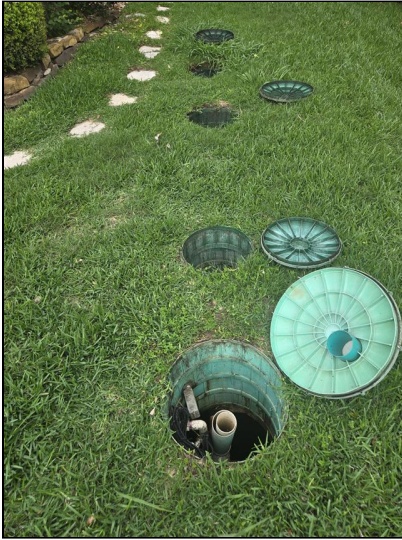
☒ ☐ ☐ ☐ B. **Booster Pump and Alarm**

The alarm float was grabbed to engage the alarm. The alarm functioned when tested.

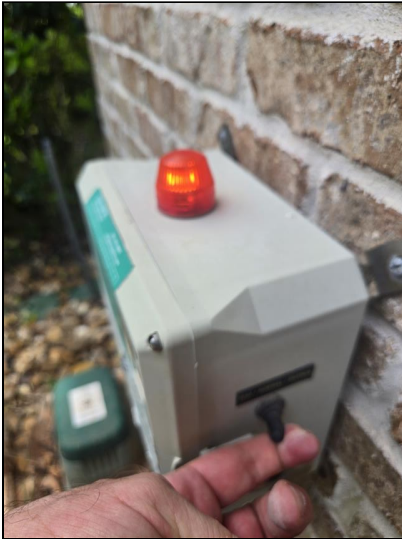
☒ ☐ ☐ ☐ C. **Visible Inspection of Inside Tank**

The tank(s) were pumped. We physically accessed (but did not enter) the tank(s). They did appear to be free of any structural defects and appeared to be functioning properly.
